Test Report

No. VNHL1807009851HG

SGS Job No. : VNHL1807009851HG
Sample Description : FILM FACED PLYWOOD
Color : BROWN – BLACK
Country of Origin : VIETNAM
Manufacturer : CONG TY TNHH SOMMA
Date of production : 01/07/2018
Sample Receiving Date : JULY 20, 2018
Final confirmed Date : JULY 20, 2018
Testing Period : JULY 20, 2018 TO AUGUST 14, 2018
Test Requested : AS CLIENT'S REQUIREMENTS
Test Results : PLEASE REFER TO NEXT PAGE(S).

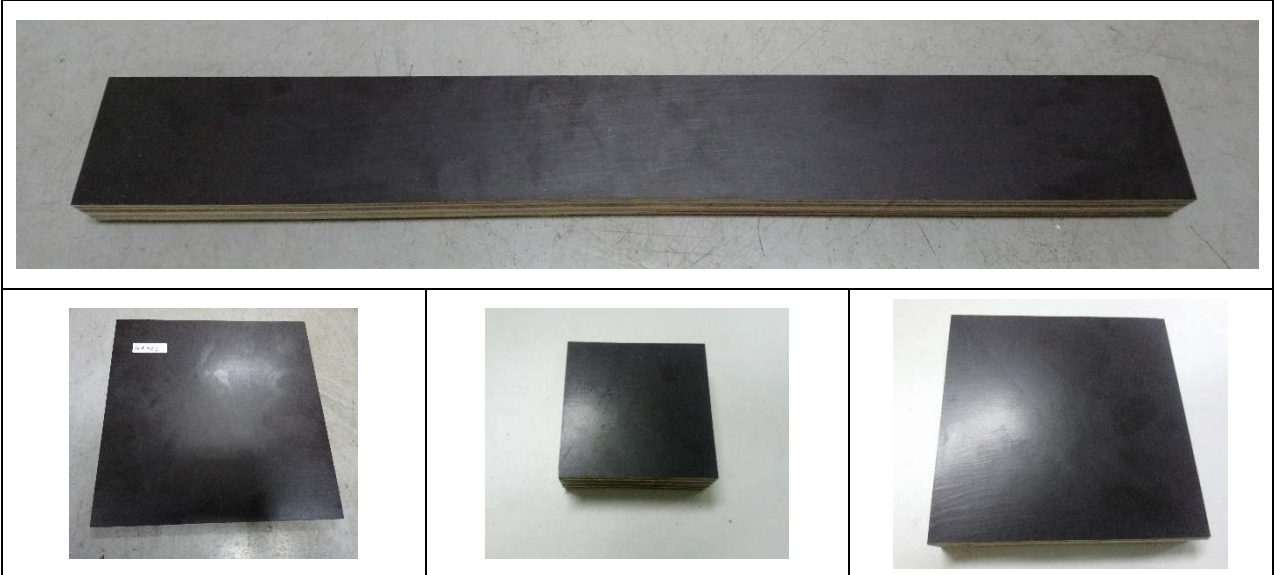
PHOTO OF SUBMITTED SAMPLE FOR TESTING
